Service Bulletin

Bulletin No.: 20-NA-078

Subject: Malfunction Indicator Lamp (MIL) Illuminated - DTC P0741 Set

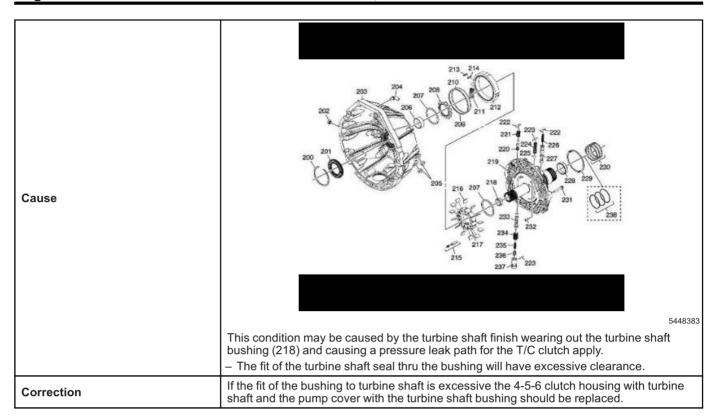
Involved Region or Country	North America	
	Some customers may comment that the MIL is Illuminated.	
Condition	Some customers may also comment that the torque converter doesn't seem to lock up.	
	Some technicians may find DTC P0741 (Torque Converter Clutch (TCC) System Stuck Off) set as an active or history code.

Refer to 4-5-6 Clutch Overhaul in SI.
